BEN GROMICKO'S TEMPLATE FOR HOME INSPECTIONS

3 Lilac Ln
Port Jefferson Station, NY 11776

01/18/2026

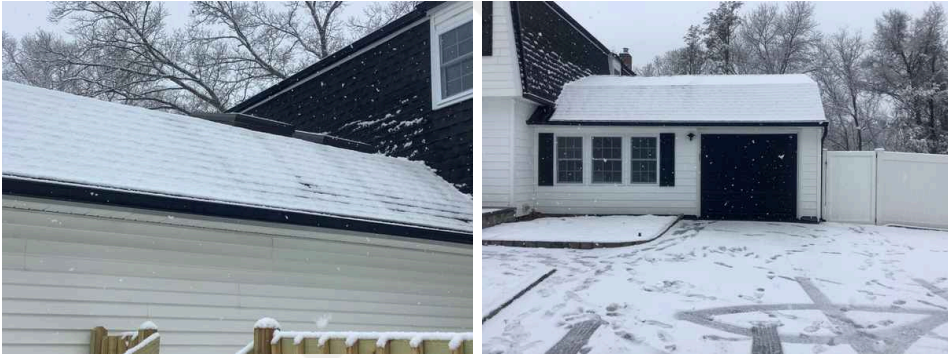
SNOW COVERING THE ROOF

There was snow covering the roof surface. This was an inspection restriction. I was unable to observe everything that I needed to see because of the snow. I recommend further evaluation at a later date when the snow has melted.

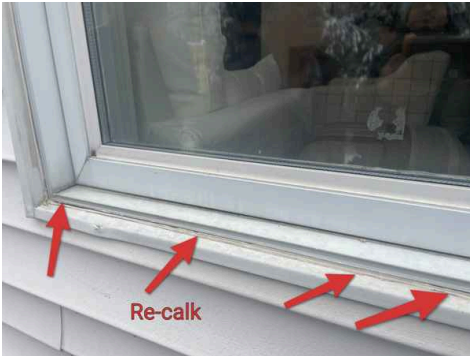
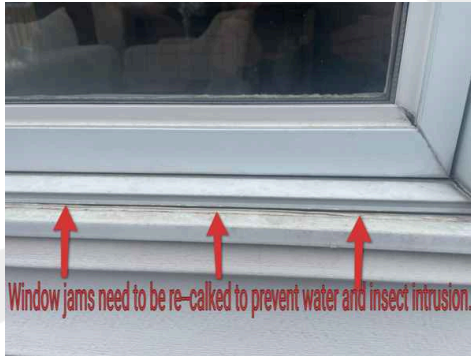
3.5.1 Flashing and Trim

POOR INSTALLATION

When the house was sided, poor installation techniques were used. It was also noted that the trim around exterior protrusions from the home were not properly flashed.

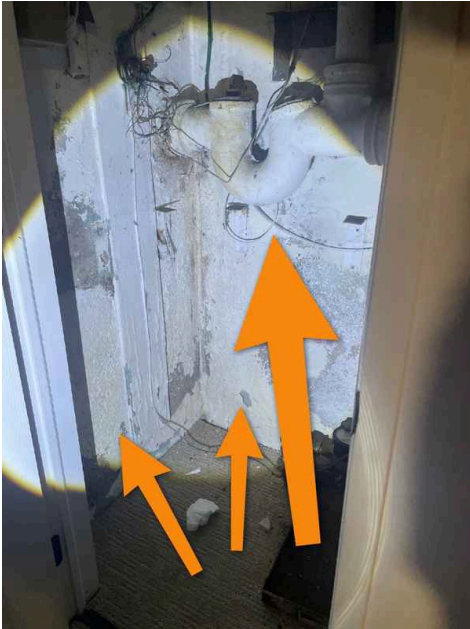
EFFLORESCENCE

BASEMENT

At the time of inspection, it was noted that there was a fluorescence in the basement in the room where the electrical panel used to be. It also appears that the basement has had water issues in the past. It is also noted that there is an installed dehumidifier in the general vicinity.

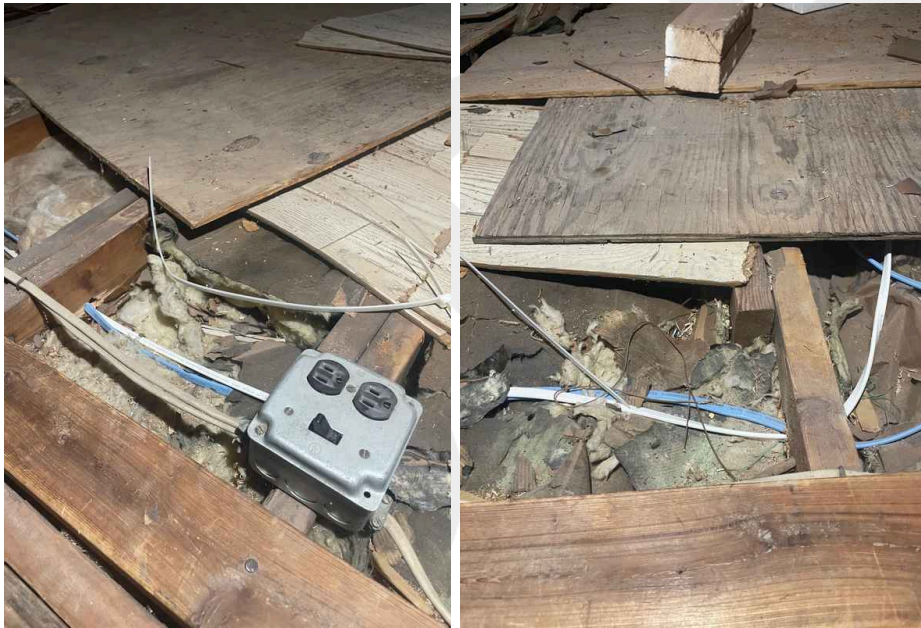
Attic

1-3 inches

At the time of inspection, the full attics insulation was not visible. The areas that were visible, showed that they were original to the house. It is recommended that a qualified professional come and assess the current or value of the attic and make the appropriate recommendations..
